**DEPARTMENT OF TRANSPORTATION****DIVISION OF ENGINEERING SERVICES**

Contract #: 04-0120F4Cty: SF/ALA Rte: 80 PM: 13.2/13.9File #: 69.28**WELDING INSPECTION REPORT****Resident Engineer:**Pursell, Gary**Address:** 333 Burma Road**City:** Oakland, CA 94607**Report No:** WIR-000694**Date Inspected:** 18-Oct-2007**Project Name:** SAS Superstructure**OSM Arrival Time:** 630**Prime Contractor:** American Bridge/Fluor Enterprises, a JV**OSM Departure Time:** 1730**Contractor:** Zhenhua Port Machinery Company, Ltd (ZPMC), Changxing Island **Location:** Shanghai, China

<b>CWI Name:</b>	Fu Guo Gang			<b>CWI Present:</b>	<b>Yes</b>	<b>No</b>	
<b>Inspected CWI report:</b>	<b>Yes</b>	<b>No</b>	<b>N/A</b>	<b>Rod Oven in Use:</b>	<b>Yes</b>	<b>No</b>	<b>N/A</b>
<b>Electrode to specification:</b>	<b>Yes</b>	<b>No</b>	<b>N/A</b>	<b>Weld Procedures Followed:</b>	<b>Yes</b>	<b>No</b>	<b>N/A</b>
<b>Qualified Welders:</b>	<b>Yes</b>	<b>No</b>	<b>N/A</b>	<b>Verified Joint Fit-up:</b>	<b>Yes</b>	<b>No</b>	<b>N/A</b>
<b>Approved Drawings:</b>	<b>Yes</b>	<b>No</b>	<b>N/A</b>	<b>Approved WPS:</b>	<b>Yes</b>	<b>No</b>	<b>N/A</b>
				<b>Delayed / Cancelled:</b>	<b>Yes</b>	<b>No</b>	<b>N/A</b>
<b>Bridge No:<

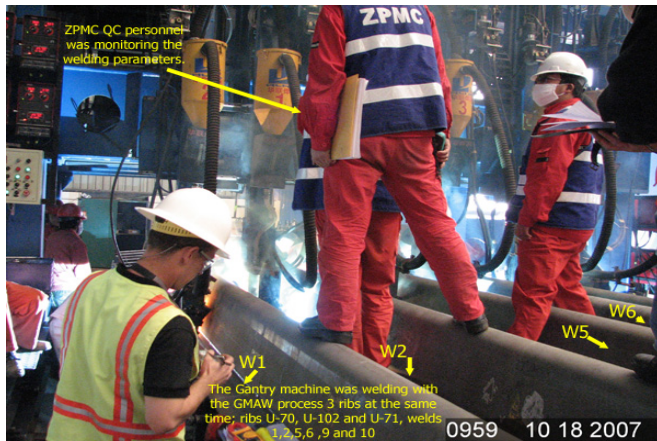
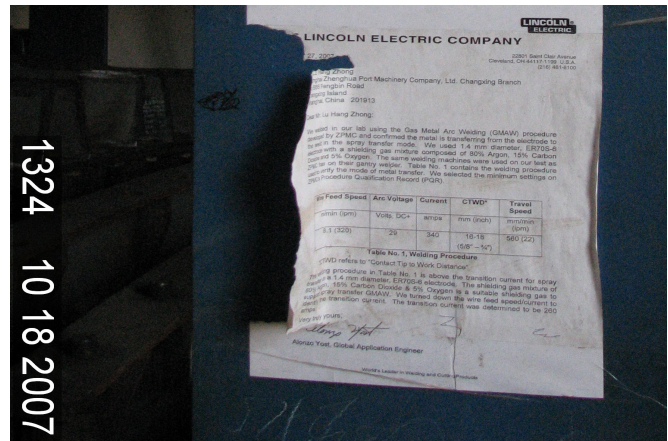
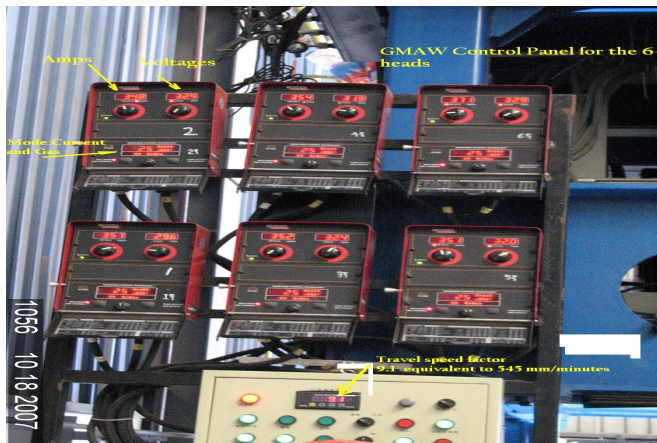
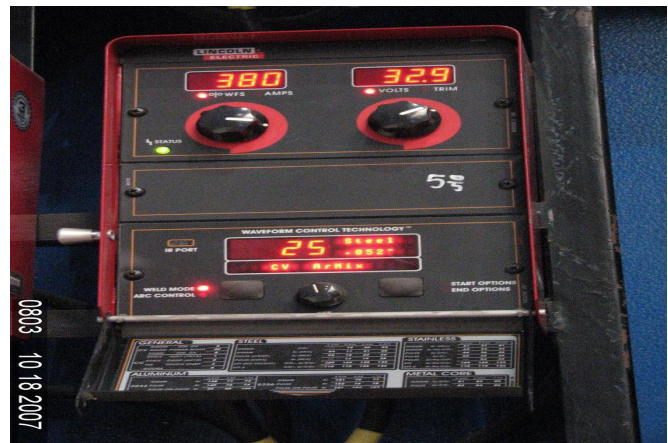
Item	Description	WBS	Dwg No.	Status
1	<p>GMAW Weld Porosity at the weld # 10, U-Rib 71</p> <p>The QA inspector observed excessive weld porosity at the first 4 meters at the U-rib U71, weld # 10. The weld porosity was found on six (6) different areas. Areas 1 through 4 were located at the first 2 meters and areas 5 and 6 were located after ZPMC restarted the second 2 meters. The digital photographs below depict the approximately locations and sizes of the defects with respect to the end of the deck plate opposite to the hand hole.</p>

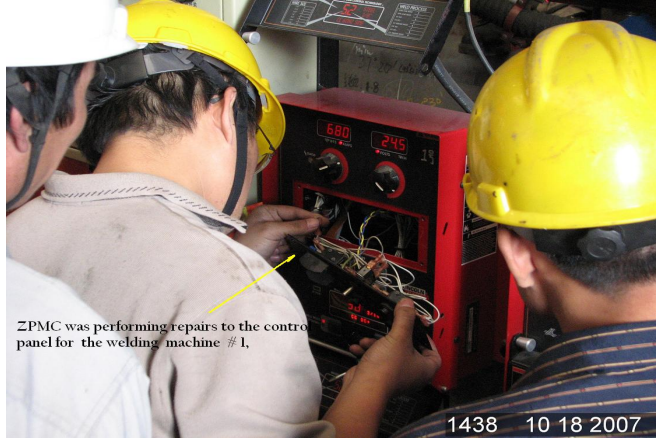
The QA inspector observed ZPMC performing adjustment to the circuitry of the Gantry machine after a machine malfunction at two welding heads caused deep gouging on the base metal. The gouging areas occurred when ZPMC was welding the cover pass with the submerged arc welding (SAW) process. The QA inspector had a conversation

with ABF representative Mr. Peter Ferguson. The QA inspector asked about the cause of the malfunction. Mr. Peter Ferguson relayed to the QA inspector that when the operator at the control panel stopped the Gantry welding machine, some of the welding heads were still continuing passing current thru the piece.

The photograph below show ZPMC maintenance personnel performing adjustment to the control panel of the Gantry.
